Field Test Report

UW Health, American Family Children's Hospital Shaft Voltage Testing

System: Return Fans #5 and #6

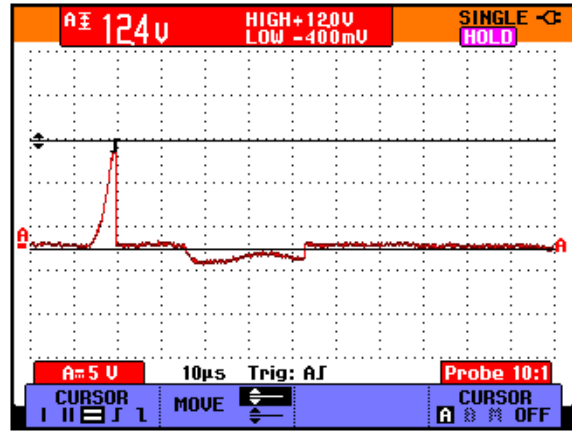
Reading 2: Shaft Voltage Reading DE
Fluke 199C Setting: 5 v/div; 10 usec/div

Observations: Isolated a single 12.4 v pk with wave form indicating a gradual rise time and sharp trailing edge voltage drop indicative of EDM bearing current.

Reading 2: 12.4 v pk

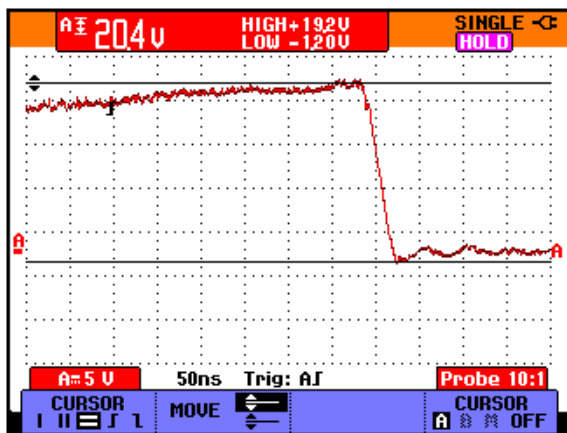
Reading 3: Shaft Voltage Reading DE
Fluke 199C Setting: 5 v/div; 50 nsec/div

Observations: Isolated a single 20.4 v pk with typical EDM discharge pattern. The rapid voltage discharge is indicative of bearing oil film breakdown and voltage discharge in the motor bearing.

Reading 3: 20.4 v pk, 40 nsec discharge time (25 MHz)
